Aviation Investigation Preliminary Report

Location:	Kearney, MO	Accident Number:	CEN23FA314
Date & Time:	July 20, 2023, 09:34 Local	Registration:	N200RA
Aircraft:	Piper PA-31P	Injuries:	1 Fatal
Flight Conducted Under:	Part 91: General aviation - Ferry

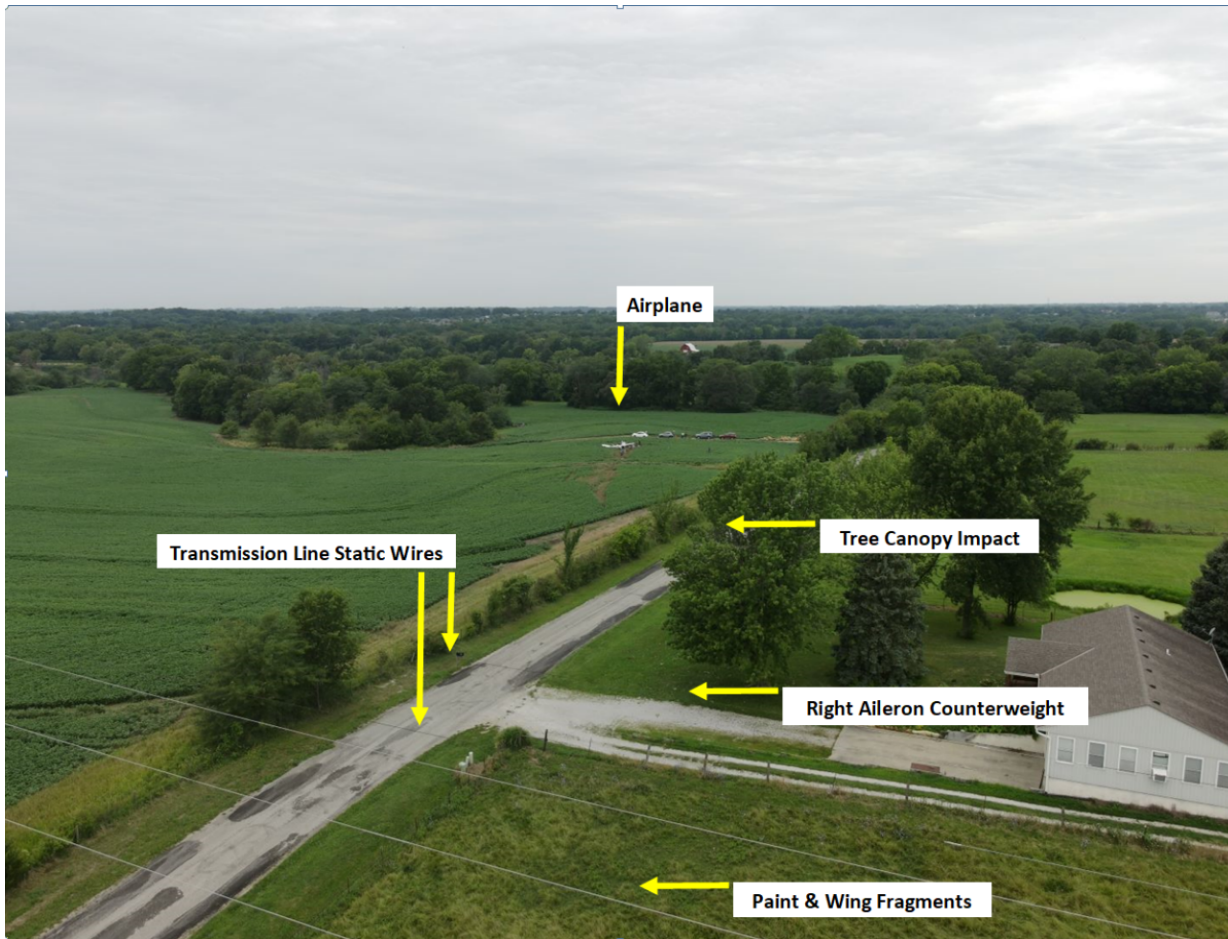
A witness about 1.60 nautical miles to the north of the airport stated he heard a loud airplane which appeared from behind trees headed towards his residence. He observed the airplane strike two static wires on a power transmission line before it impacted the canopy of a large tree in his front yard (see Figure 2.). The airplane continued in a left bank toward a nearby soybean field and impacted the terrain in a nose-low, left bank attitude. The airplane slid several hundred feet, and a postcrash fire ensued.

Figure 2. Transmission line and tree impact provided by the IIC

The accident site was located in a relatively flat agricultural field about 1.6 nautical miles north of the runway. The wires were located about 735 ft before the main wreckage and were about 65 ft above ground level (agl). The second identified point of contact was tree canopy impact about 60 ft AGL and 150 ft after the wire strike. The airplane then impacted the ground and a debris path extended in the field about 313 ft. on a heading of 254°, to the main wreckage.
